**Flood Control Project Maintenance
Levee Inspections**

Maintenance Issue Types Only, Levee Inspection Report By Mile - Spring 2017

Reclamation District No. 0524 Middle Roberts Island

Waterway	Bank	Unit Miles	Inspection Start/End	Inspector
Unit No. 01 San Joaquin River	Left	6.20	04/04/2017 04/05/2017	Richard Willoughby

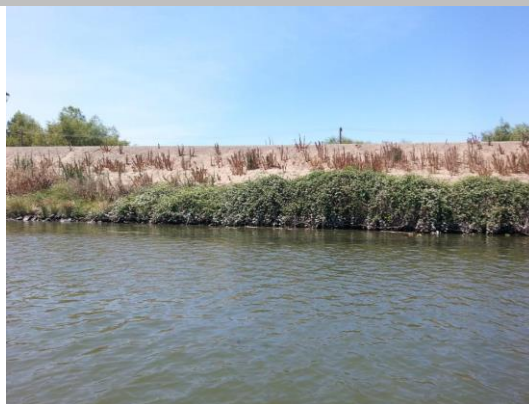
Photo 1 of 3 : SP_2017_RD0524_107_5_20170316_00011.jpg

LM Start	0.19	Rating **	U	Issue No.	5
LM End	0.19	Issue Type +	Ma	Location *	WS
Category	Supplemental			GPS Latitude/Longitude	
				Start	End
Item	DWR Erosion Survey			37.939085 °	37.939085 °
				-121.343917 °	-121.343917 °
DWR ID	DWR_RD0524_01_s_2017_5				
Comment Code					
Inspector Comment					
07/25/2016: No significant change observed.					
06/24/2015: No significant change observed.					
06/19/2014: No significant change observed.					
08/13/2013: The erosion was discovered during 2013 spring levee inspection. Inspector comment: Erosion is located along the lower level of water-ward slope. [2016 Site ID:RD0524U01RM40.85]

Close view of the erosion.

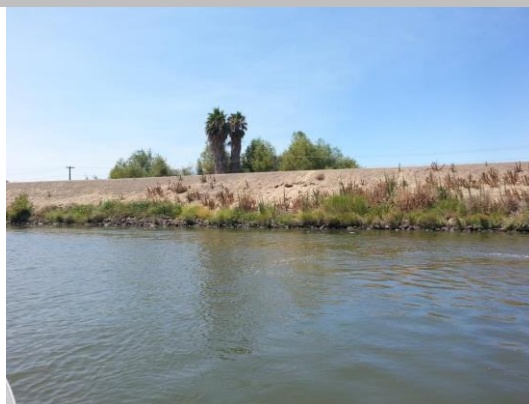
Photo 2 of 3 : SP_2017_RD0524_107_5_20170316_00012.jpg

Close view of the erosion.

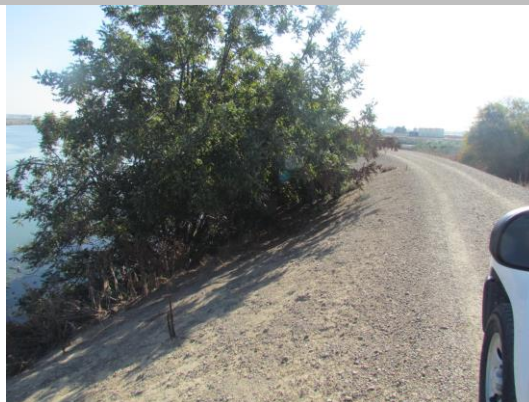
Photo 1 of 1 : SP_2017_RD0524_107_201_20170316_00232.jpg

Looking east at untrimmed tree on landward slope.

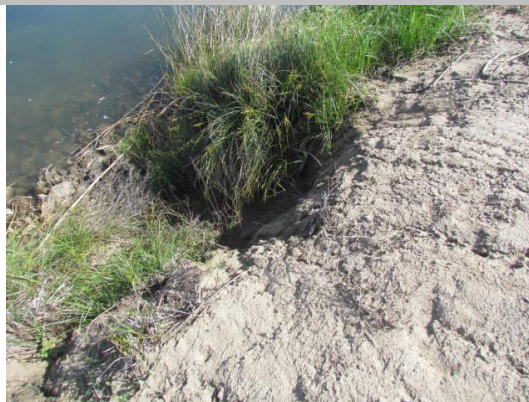
Photo 1 of 2 : SP_2017_RD0524_107_180_20170316_00216.jpg

LM Start	0.34	Rating **	M	Issue No.	180
LM End	0.34	Issue Type +	Ma	Location *	WS
Category	Earthen Levee			GPS Latitude/Longitude	
				Start	End
Item	Erosion / Bank Caving			37.938461 °	37.938461 °
				-121.341626 °	-121.341626 °
DWR ID	DWR_RD0524_01_s_2014_180				
Comment Code					
E2 : Schedule repair of erosion site prior to the next inspection.					
Inspector Comment					
Erosion is located along the lower level of waterward slope.

Looking southeast at erosion on waterward toe.

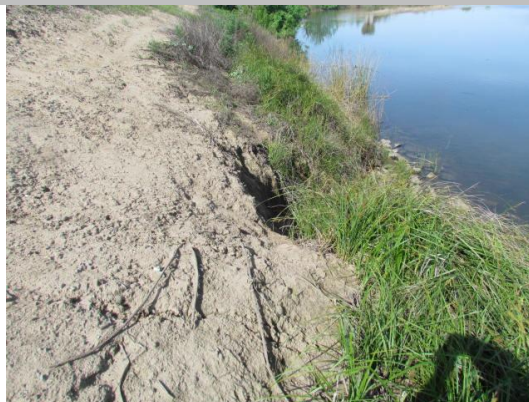
Photo 2 of 2 : SP_2017_RD0524_107_180_20170316_00217.jpg

Looking northeast at erosion on waterward toe.

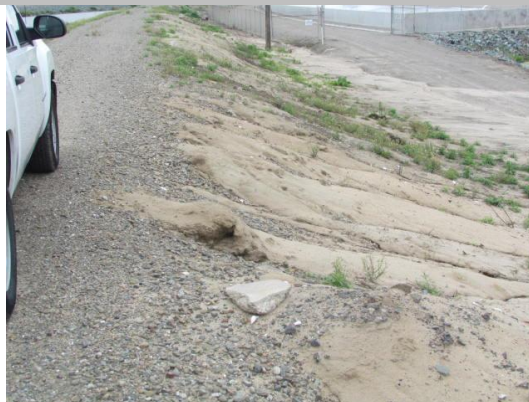
Photo 2 of 2 : SP_2017_RD0524_107_205_20170316_00238.jpg

LM Start	0.40	Rating **	U	Issue No.	205
LM End	0.46	Issue Type +	Ma	Location *	LS
Category	Earthen Levee			GPS Latitude/Longitude	
				Start	End
Item	Erosion / Bank Caving			37.938625 °	37.938695 °
				-121.340479 °	-121.339420 °
DWR ID	DWR_RD0524_01_s_2016_205				
Comment Code					
E2 : Schedule repair of erosion site prior to the next inspection.					
Inspector Comment					
Several damage site within this reach.

Looking at slope damage on landward slope.

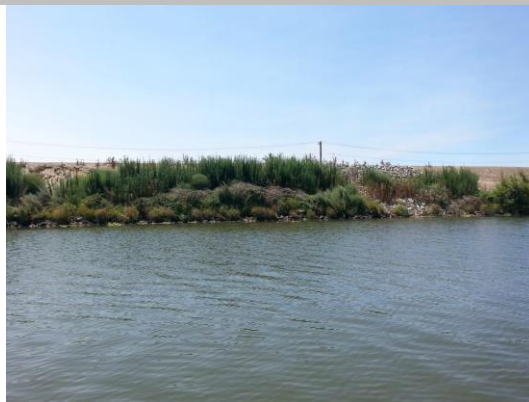
Photo 2 of 3 : SP_2017_RD0524_107_16_20170316_00033.jpg

LM Start	0.40	Rating **	A/W	Issue No.	16	
LM End	0.40	Issue Type +	Ma	Location *	WS	
Category	Supplemental			GPS Latitude/Longitude		
				Start	End	
Item	DWR Erosion Survey			37.938870 °	37.938870 °	
				-121.340460 °	-121.340460 °	
DWR ID	DWR_RD0524_01_s_2017_16					
Comment Code						
Inspector Comment						
04/04/17: Site repaired						
07/25/2016: More vegetation observed at the site.						
06/24/2015: No significant change observed.						
06/19/2014: No significant change observed.						
08/13/2013: No significant change at this site.						
08/07/2012: The erosion is at the upper levee slope, and likely caused by slope slip. The lower levee slope is covered with dense vegetation.						
[2016 Site ID:RD0524U01RM40.99]

Front view of the site.

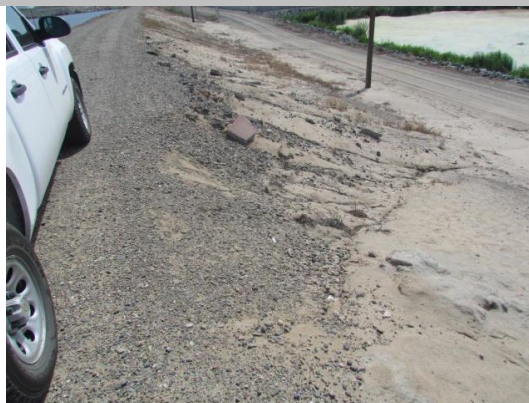
Photo 2 of 3 : SP_2017_RD0524_107_170_20170316_00198.jpg

Looking at slope damage on waterward shoulder.

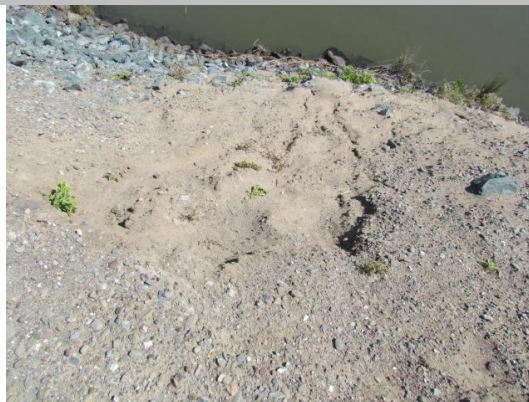
Photo 1 of 3 : SP_2017_RD0524_107_10_20170316_00017.jpg

LM Start	0.63	Rating **	U	Issue No.	10
LM End	0.63	Issue Type +	Ma	Location *	WS
Category	Earthen Levee			GPS Latitude/Longitude	
				Start	End
Item	Erosion / Bank Caving			37.938247 °	37.938247 °
				-121.336503 °	-121.336503 °
DWR ID	DWR_RD0524_01_f_2015_10				
Comment Code					
E2 : Schedule repair of erosion site prior to the next inspection.					
Inspector Comment					
Erosion located next to and under bamboo.

Looking east at waterside erosion appears to be caused by runoff.

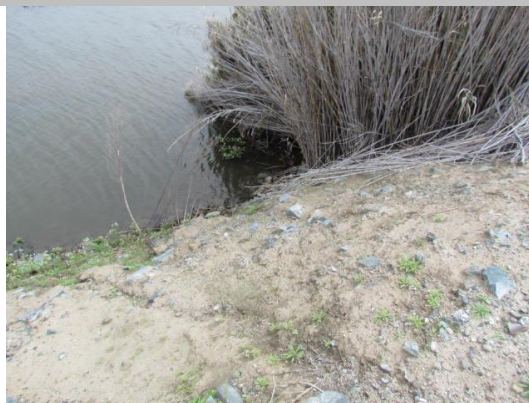
Photo 3 of 3 : SP_2017_RD0524_107_10_20170316_00019.jpg

Looking east at erosion under bamboo on waterward slope.

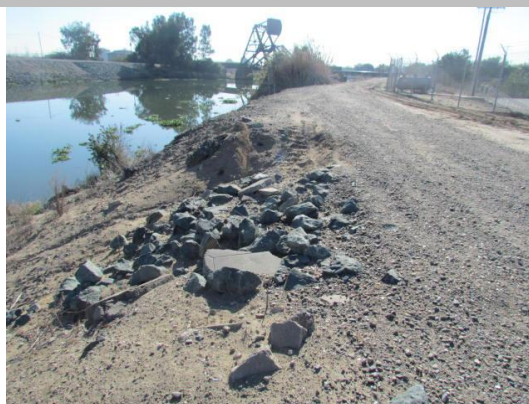
Photo 1 of 4 : SP_2017_RD0524_107_13_20170316_00026.jpg

LM Start	0.64	Rating **	M	Issue No.	13
LM End	0.65	Issue Type +	Ma	Location *	WS
Category	Earthen Levee			GPS Latitude/Longitude	
				Start	End
Item	Slope Stability			37.938105 °	37.938023 °
				-121.336288 °	-121.336173 °
DWR ID	DWR_RD0524_01_s_2012_13				
Comment Code					
S1 : Repair slope instability.					
Inspector Comment					
Depression extend from shoulder to mid levee slope two site with this section.

Looking southeast at depression on waterward shoulder fall 2015

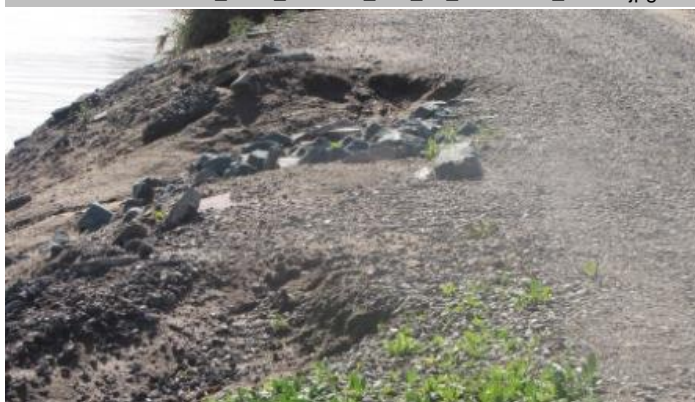
Photo 2 of 4 : SP_2017_RD0524_107_13_20170316_00027.jpg

Looking south at erosion on waterside shoulder.

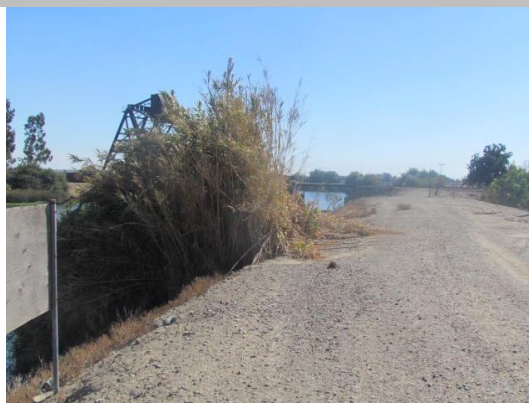
Photo 3 of 3 : SP_2017_RD0524_107_14_20170316_00032.jpg

Looking south at bamboo on waterside slope. (Fall 2012)

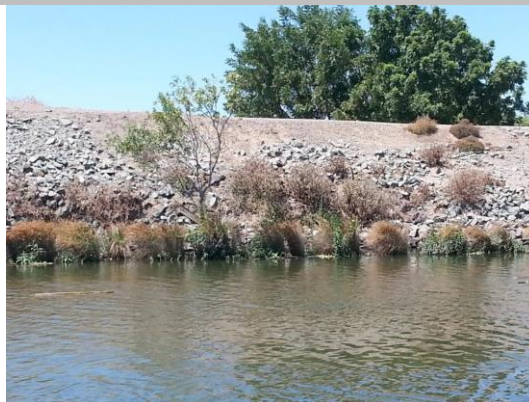
Photo 1 of 1 : SP_2017_RD0524_107_17_20170316_00035.jpg

LM Start	0.71	Rating **	M	Issue No.	17
LM End	0.73	Issue Type +	Ma	Location *	WS
Category	Supplemental			GPS Latitude/Longitude	
				Start	End
Item	DWR Erosion Survey			37.937222 °	37.937222 °
				-121.335277 °	-121.335277 °
DWR ID	DWR_RD0524_01_s_2017_17				
Comment Code					
Inspector Comment					
07/25/2016: No significant change observed.					
06/24/2015: The erosion site is immediately downstream of the RR bridge. [2016 Site ID:RD0524U01RM41.36]

Close view of the erosion.

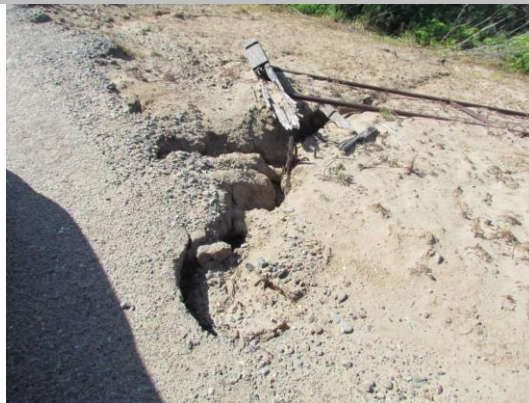
Photo 1 of 2 : SP_2017_RD0524_107_157_20170407_00380.jpg

LM Start	0.72	Rating **	U	Issue No.	157
LM End	0.72	Issue Type +	Ma	Location *	LS
Category	Earthen Levee			GPS Latitude/Longitude	
				Start	End
Item	Erosion / Bank Caving			37.937290 °	37.937290 °
				-121.335417 °	-121.335417 °
DWR ID	DWR_RD0524_01_s_2017_157				
Comment Code					
Inspector Comment					
Slope damage caused by rain runoff on landward slope.

Looking west at slope damage caused by rain runoff on landward slope.

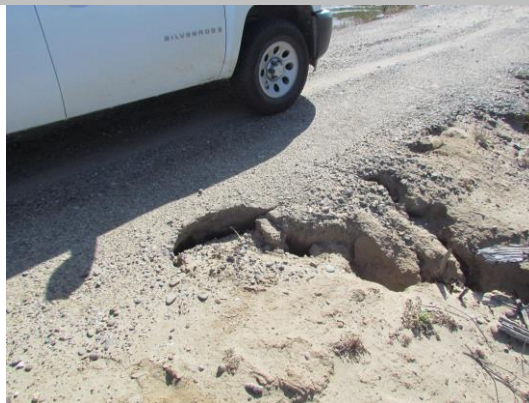
Photo 2 of 2 : SP_2017_RD0524_107_157_20170407_00381.jpg

Looking south at slope damage caused by rain runoff on landward slope.

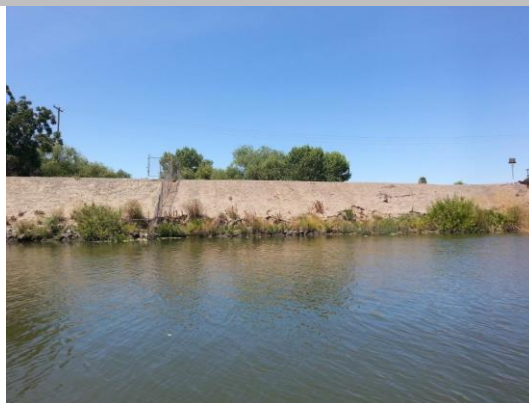
Photo 2 of 2 : SP_2017_RD0524_107_21_20170316_00045.jpg

Front view of the erosion.

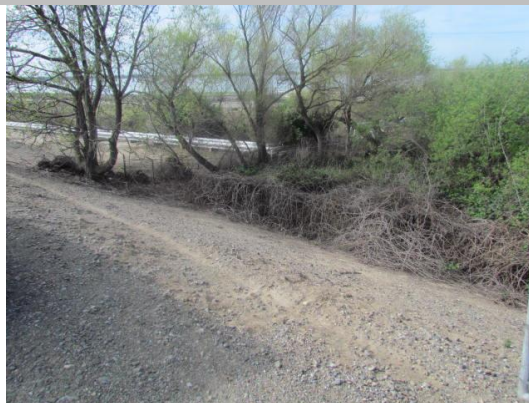
Photo 3 of 3 : SP_2017_RD0524_107_262_20170316_00263.jpg

Looking southwest at vegetation on landward slope and toe. (Spring 2013)

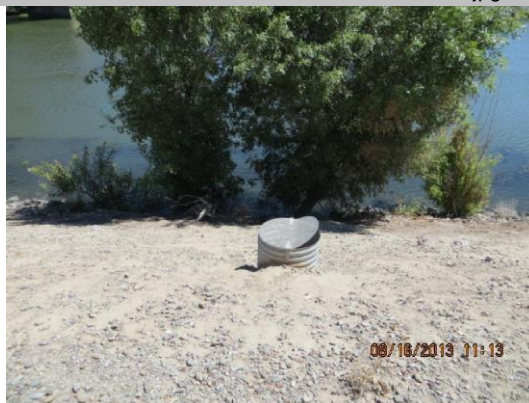
Photo 1 of 2 : UCIP_SP_2017_17571_29719.jpg

LM Start	0.78	Rating **	M	Issue No.	936
LM End	0.78	Issue Type +	Ma	Location *	LS
Category	Supplemental			GPS Latitude/Longitude	
				Start	End
Item	DWR UCIP LMA Responsibility			37.936474 °	37.936474 °
				-121.334830 °	-121.334830 °
DWR ID					
Comment Code					
Inspector Comment					
FS_ID:17571					
DS_ID:20596					
EP_NO: N/A					
Repair Type: Non-Urgent					
Crossing Status: Found					
UCIP Comments: Large hole in pipe at WS toe. Appears abandoned and should be done so properly.					
FIELD_STRUCT_DESC: 8-inch steel drain pipe through the levee 4.0 feet below the crown. Pump at the toe of the landward slope (not found 8/16/13). Siphon breaker in 24-inch cmp Riser on the waterward slope. Originally included in the 1964 O&M manual.					
FS Date: 8/16/2013

Siphon breaker in 24-inch cmp riser on WS slope.

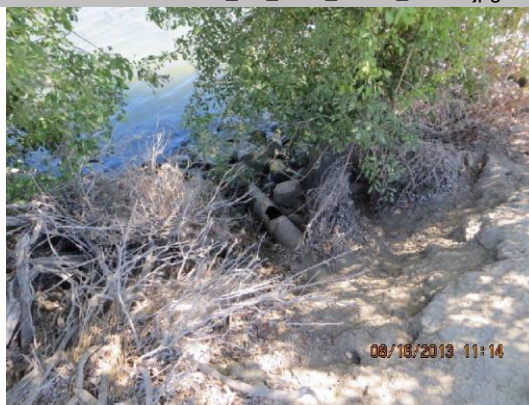
Photo 2 of 2 : UCIP_SP_2017_17571_29718.jpg

Large hole in pipe at WS toe.

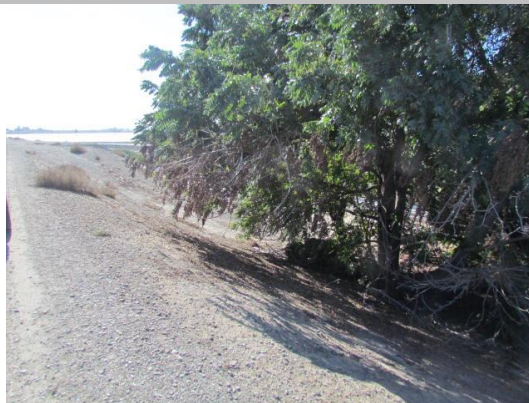
Photo 1 of 1 : SP_2017_RD0524_107_76_20170316_00124.jpg

Looking southwest at low hanging tree branches at landside toe.

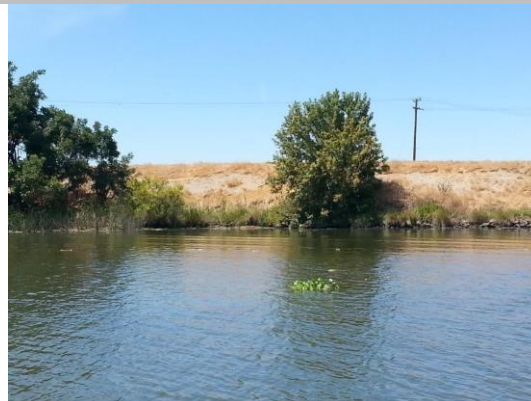
Photo 1 of 2 : SP_2017_RD0524_107_22_20170316_00046.jpg

LM Start	0.83	Rating **	U	Issue No.	22
LM End	0.84	Issue Type +	Ma	Location *	WS
Category	Supplemental			GPS Latitude/Longitude	
				Start	End
Item	DWR Erosion Survey			37.935930 °	37.935930 °
				-121.334133 °	-121.334133 °
DWR ID	DWR_RD0524_01_s_2017_22				
Comment Code					
Inspector Comment					
07/25/2016: No significant change observed.					
06/24/2015: No significant change observed.					
06/19/2014: No significant change observed.					
08/13/2013: Site was discovered during boat survey. The dense vegetation blocks a clear view of the erosion. Size of erosion site was very roughly estimated. [2016 Site ID:RD0524U01RM41.44]

Close view of the erosion site.

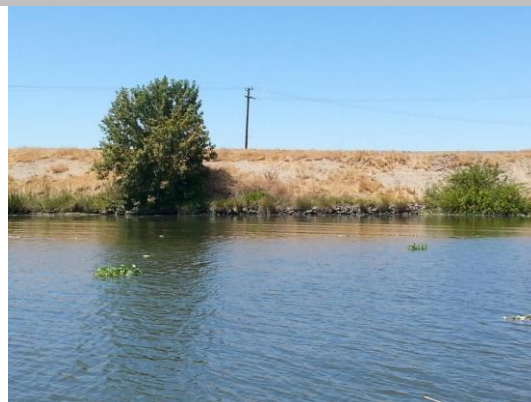
Photo 2 of 2 : SP_2017_RD0524_107_22_20170316_00047.jpg

Front view of the erosion.

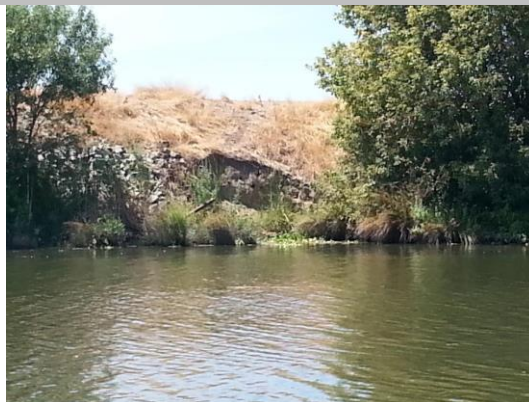
Photo 2 of 2 : SP_2017_RD0524_107_33_20170316_00064.jpg

Close view of the erosion.

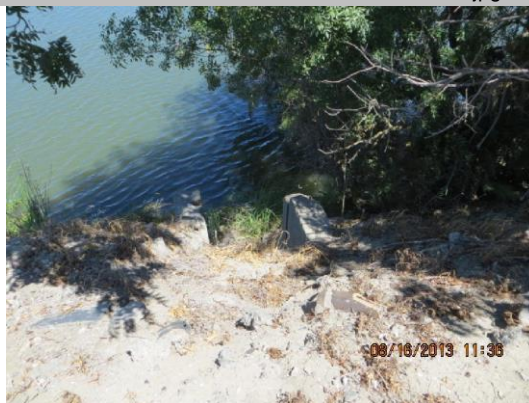
Photo 1 of 2 : UCIP_SP_2017_17575_29736.jpg

Concrete headwall visible on WS slope.

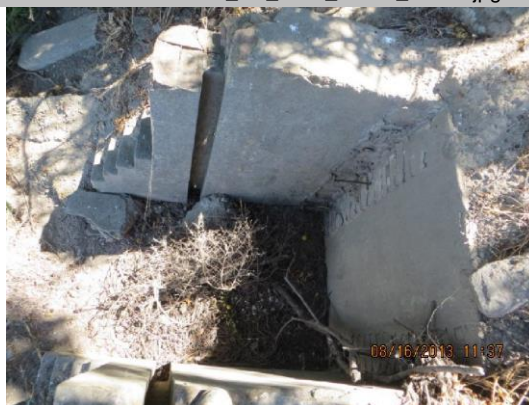
Photo 2 of 2 : UCIP_SP_2017_17575_29735.jpg

Slide gate removed from headwall on WS slope.

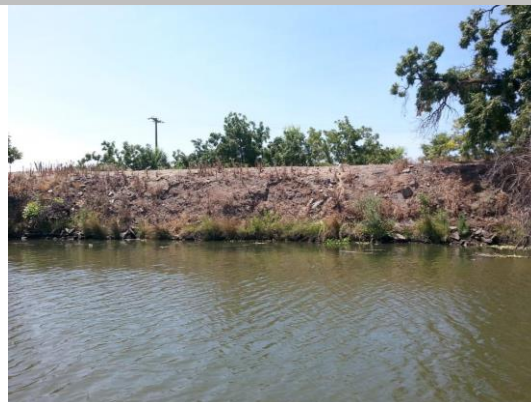
Photo 1 of 2 : SP_2017_RD0524_107_47_20170316_00089.jpg

Front view of the erosion.

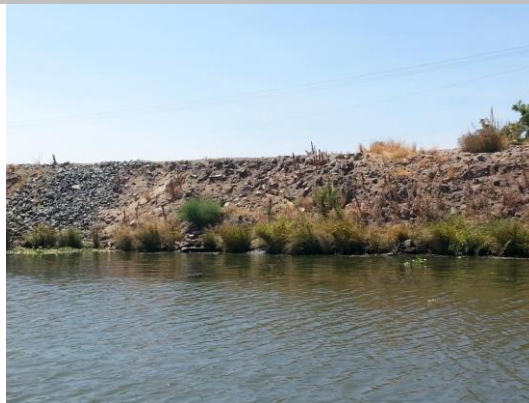
Photo 3 of 3 : SP_2017_RD0524_107_55_20170316_00101.jpg

Front view of the erosion.

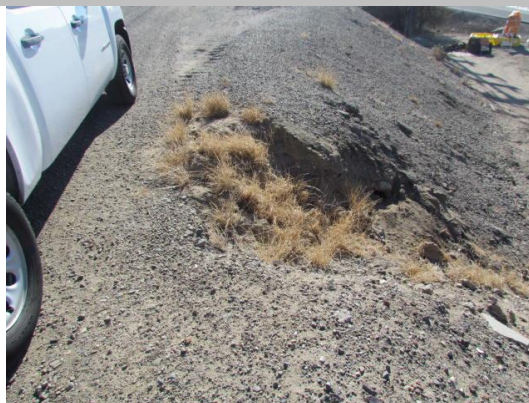
Photo 1 of 7 : SP_2017_RD0524_107_18_20170316_00036.jpg

Looking south at caving on landward shoulder. (Fall 2015)

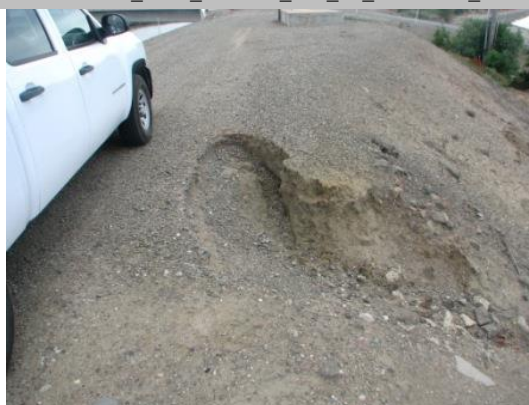
Photo 2 of 7 : SP_2017_RD0524_107_18_20170316_00038.jpg

Landward slope damage. Spring 2014

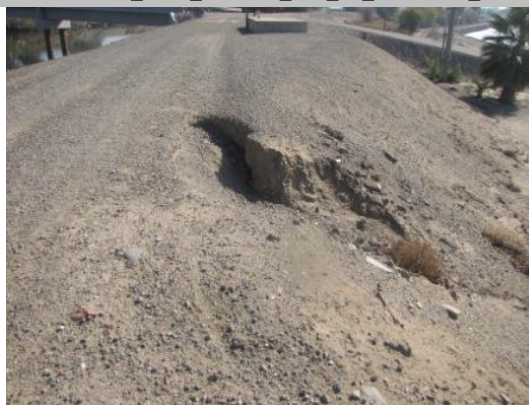
Photo 3 of 7 : SP_2017_RD0524_107_18_20170316_00039.jpg

Updated picture of the erosion site on the landside shoulder. Fall 2014

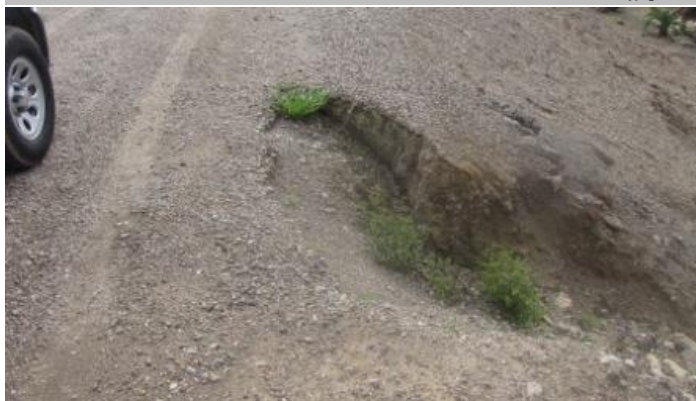
Photo 6 of 7 : SP_2017_RD0524_107_18_20170316_00041.jpg

Looking at updated slope stability as of Fall 2013.

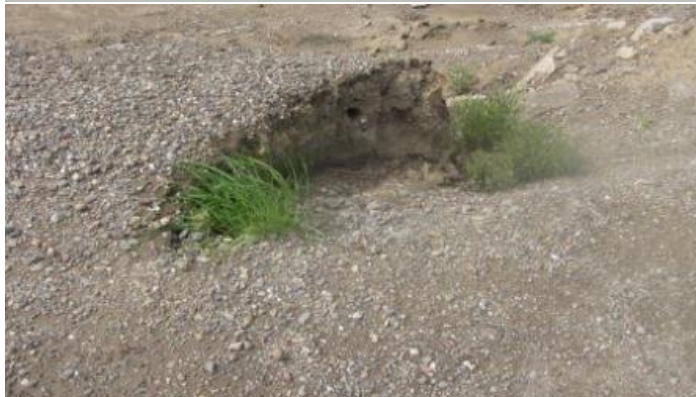
Photo 7 of 7 : SP_2017_RD0524_107_18_20170316_00042.jpg

Updated view from above the slope stability.

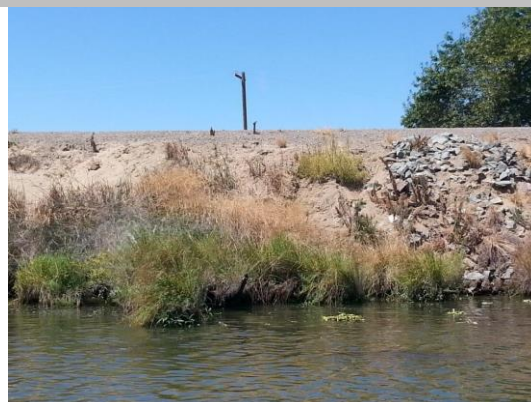
Photo 2 of 3 : SP_2017_RD0524_107_60_20170316_00106.jpg

Close view of the erosion.

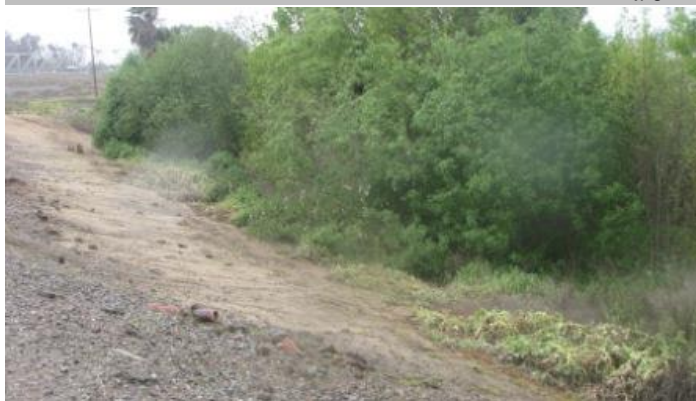
Photo 4 of 4 : SP_2017_RD0524_107_915_20170316_00272.jpg

Looking southwest at dense veg. on landside toe. (Fall 2015)

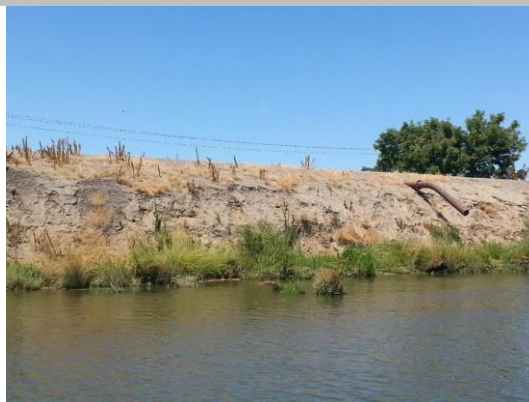
Photo 3 of 3 : SP_2017_RD0524_107_71_20170316_00117.jpg

Front view of the erosion. Note the drainage pipe on the site.

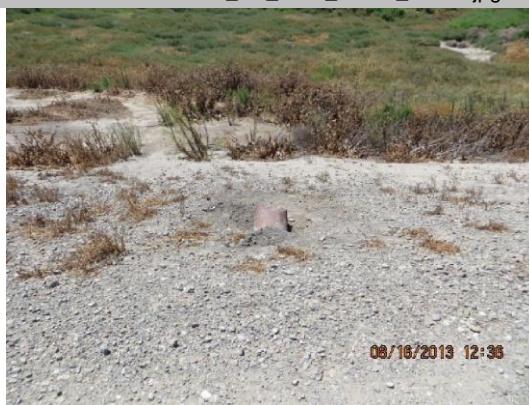
Photo 2 of 3 : UCIP_SP_2017_51319_29861.jpg

Pipe open and visible on LS slope.

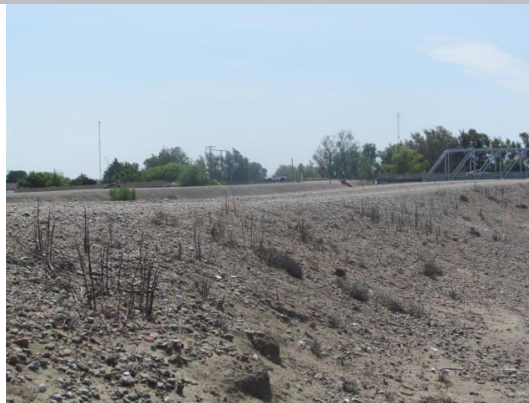
Photo 1 of 2 : SP_2017_RD0524_107_172_20170316_00201.jpg

Looking east at depression on levee crown.

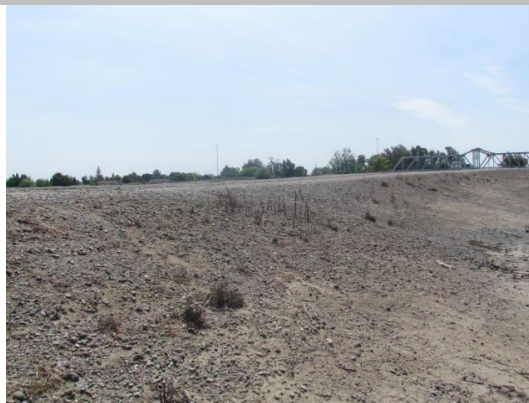
Photo 2 of 2 : SP_2017_RD0524_107_172_20170316_00202.jpg

Looking southeast at depression on levee crown.

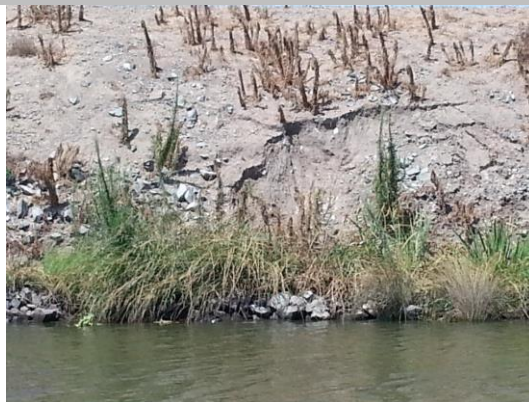
Photo 2 of 3 : SP_2017_RD0524_107_79_20170316_00128.jpg

Close view of the erosion.

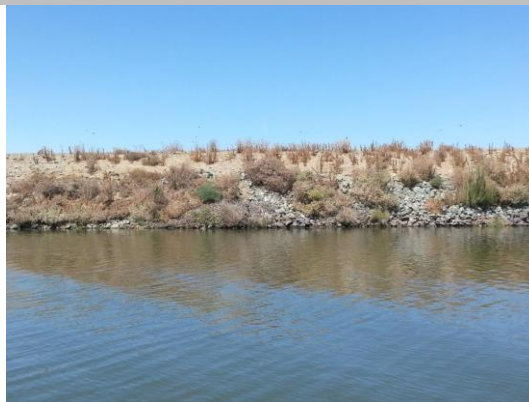
Photo 1 of 2 : SP_2017_RD0524_107_89_20170316_00142.jpg

Close view of the erosion. Note the vegetation at the site.

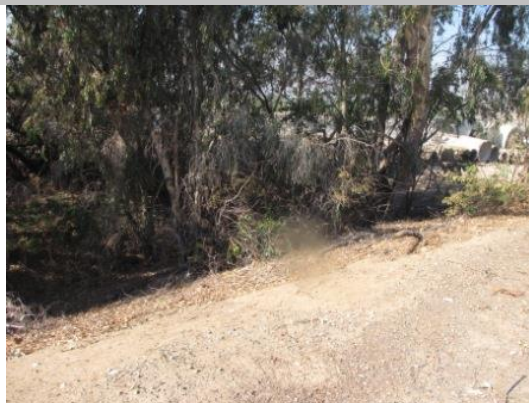
Photo 4 of 4 : SP_2017_RD0524_107_916_20170316_00276.jpg

Dense vegetation on landside toe.

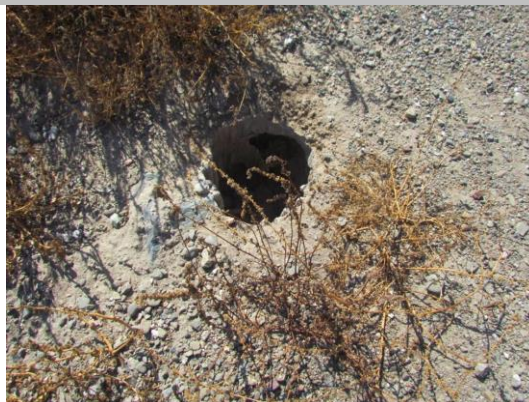
Photo 1 of 2 : SP_2017_RD0524_107_202_20170316_00233.jpg

Looking at hole on waterward shoulder.

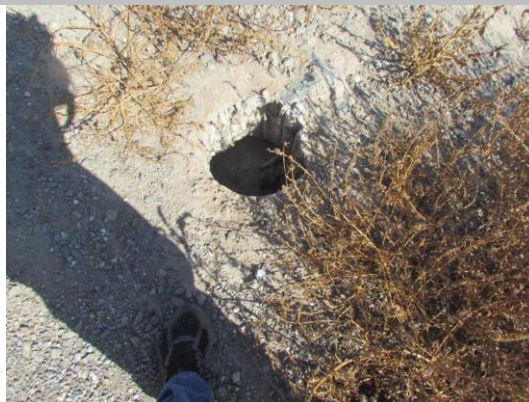
Photo 2 of 2 : SP_2017_RD0524_107_202_20170316_00234.jpg

Looking at large hole (Fence/telephone post hole) on waterward shoulder.

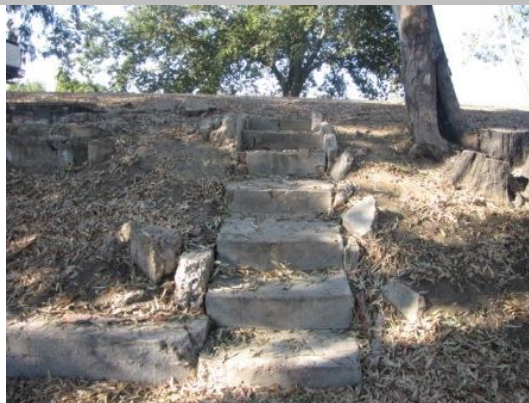
Photo 3 of 3 : SP_2017_RD0524_107_45_20170316_00084.jpg

Looking west at concrete stairs on waterside slope.

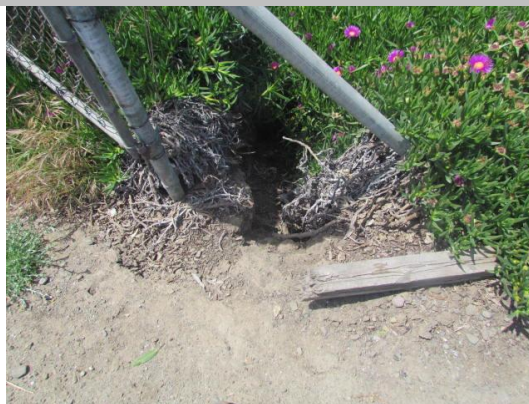
Photo 1 of 2 : SP_2017_RD0524_107_176_20170316_00208.jpg

Looking west at erosion within landscaping on landward shoulder and slope.

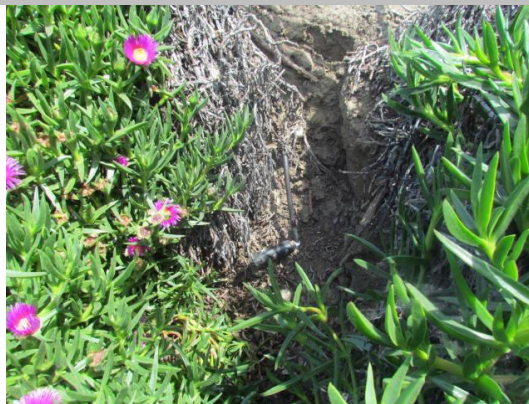
Photo 2 of 2 : SP_2017_RD0524_107_176_20170316_00209.jpg

Looking east at erosion within landscaping on landward slope and shoulder.

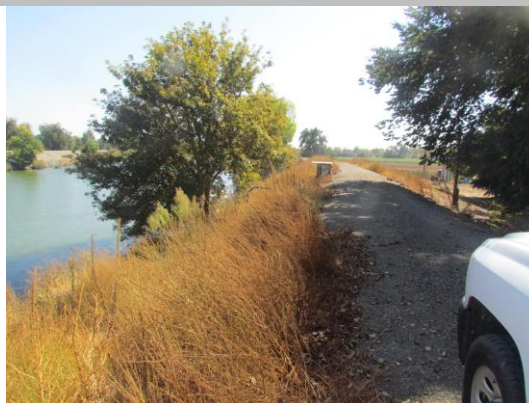
Photo 1 of 1 : SP_2017_RD0524_107_6_20170316_00014.jpg

Looking southeast at dense veg on waterward slope.

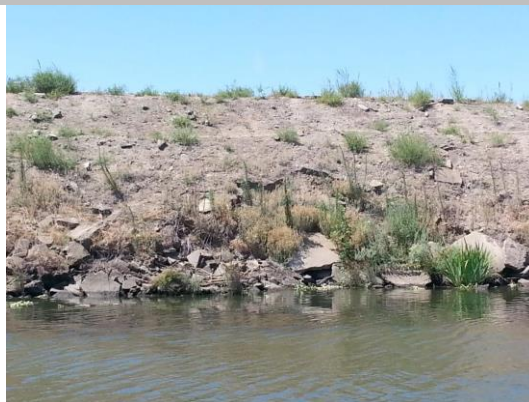
Photo 1 of 2 : SP_2017_RD0524_107_91_20170316_00147.jpg

Close view of the pocket erosion.

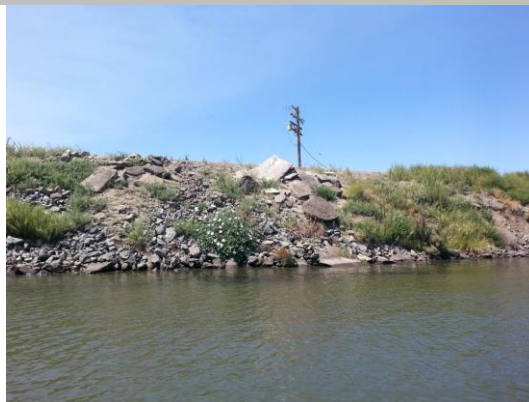
Photo 1 of 3 : SP_2017_RD0524_107_99_20170316_00158.jpg

Close view of the erosion.

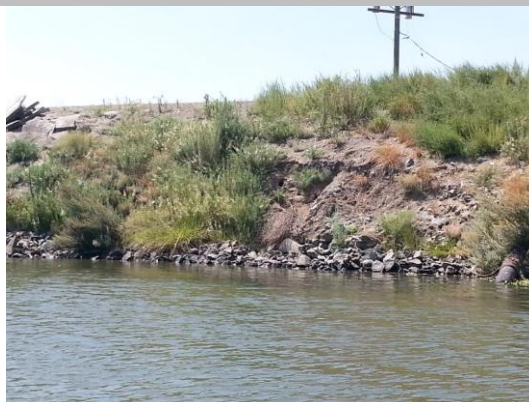
Photo 3 of 3 : SP_2017_RD0524_107_99_20170316_00160.jpg

Close view of the erosion. Note the irrigation pipe next to the erosion.

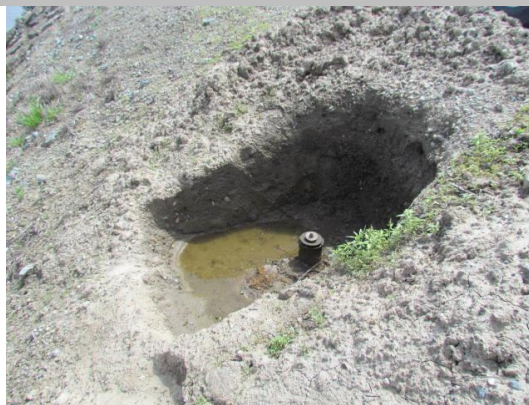
Photo 1 of 3 : SP_2017_RD0524_107_31_20170316_00058.jpg

Looking south at siphon on waterward slope.

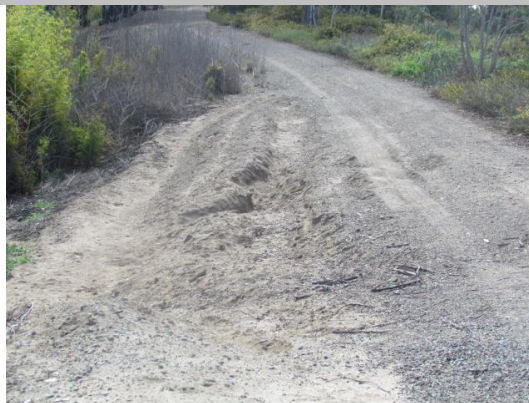
Photo 3 of 3 : SP_2017_RD0524_107_31_20170316_00060.jpg

Looking south slope damage on waterward shoulder and slope.

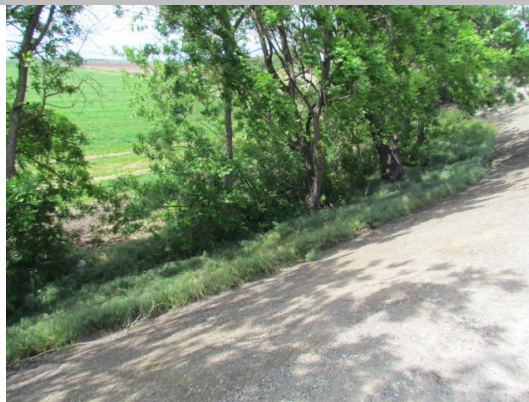
Photo 1 of 1 : SP_2017_RD0524_107_107_20170316_00165.jpg

Looking northwest at untrimmed trees at landward toe.

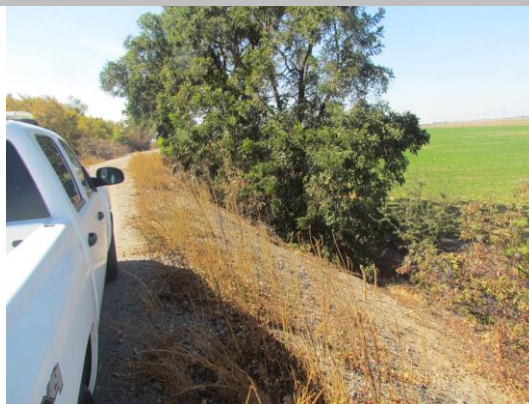
Photo 1 of 1 : SP_2017_RD0524_107_80_20170316_00130.jpg

Looking south at untrimmed tree on landward slope.

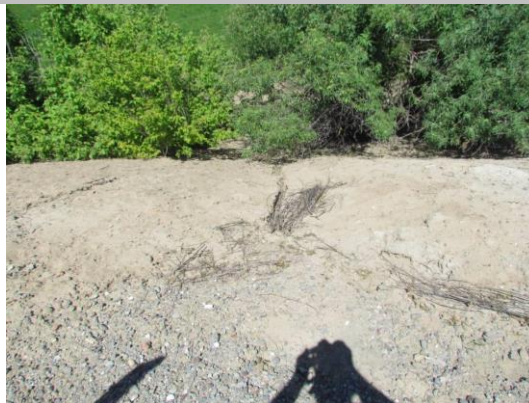
Photo 1 of 1 : SP_2017_RD0524_107_160_20170407_00386.jpg

Looking east at erosion caused by rain runoff on waterward slope.

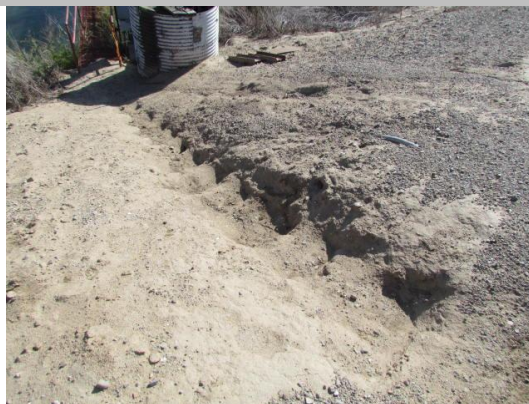
Photo 2 of 2 : SP_2017_RD0524_107_58_20170316_00103.jpg

Looking southeast steps cut into waterside slope.

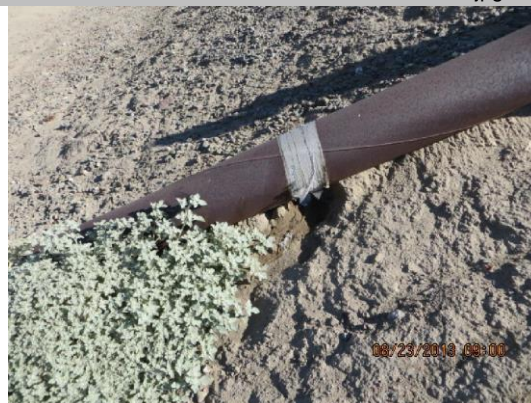
Photo 2 of 3 : UCIP_SP_2017_18320_30593.jpg

Small leak in pipe on LS slope.

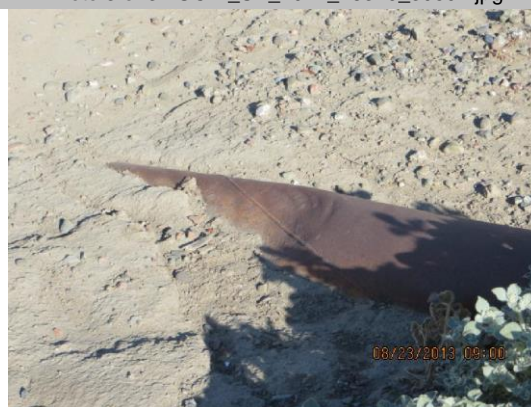
Photo 3 of 3 : UCIP_SP_2017_18320_30592.jpg

Pipe partially crushed at LS toe.

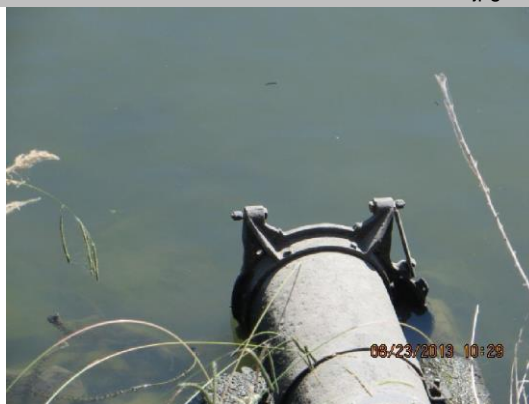
Photo 3 of 3 : UCIP_SP_2017_51633_30687.jpg

Broken flap gate at WS toe.

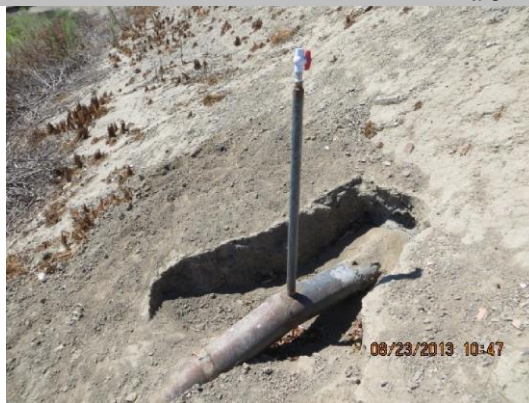
Photo 2 of 3 : UCIP_SP_2017_18348_30705.jpg

8-inch pipe sleeved through 10-inch pipe with vent on WS slope.

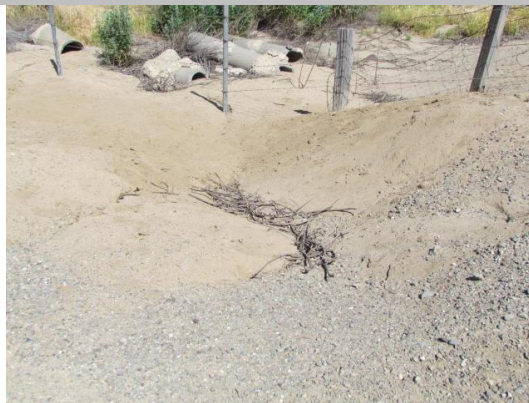
Photo 1 of 3 : SP_2017_RD0524_107_118_20170316_00177.jpg

Looking west at slope damage on landside slope.

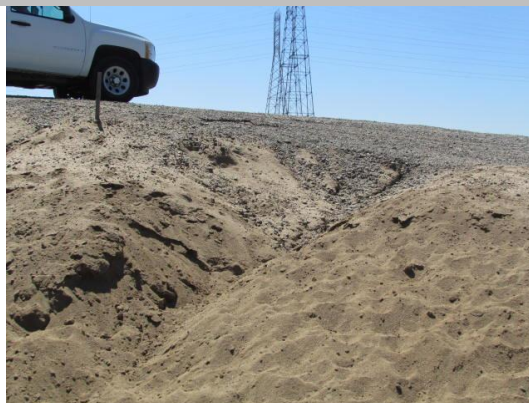
Photo 2 of 3 : SP_2017_RD0524_107_118_20170316_00178.jpg

Looking southeast at damaged slope.

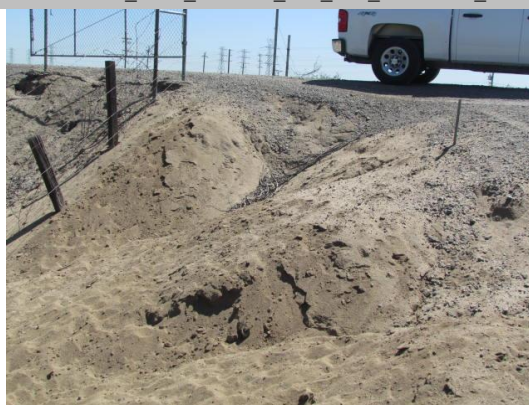
Photo 3 of 3 : SP_2017_RD0524_107_118_20170316_00179.jpg

Looking east at slope caving on landside slope.

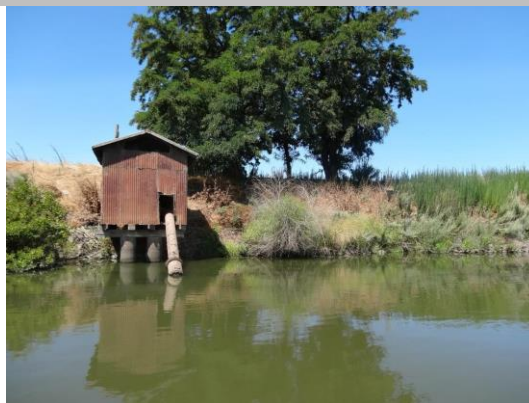
Photo 1 of 2 : SP_2017_RD0524_107_135_20170316_00191.jpg

Close view of the site. Note large trees at the levee shoulder.

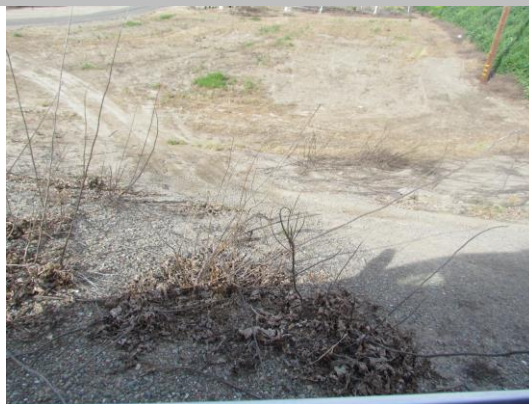
Photo 1 of 1 : SP_2017_RD0524_107_168_20170407_00394.jpg

Looking northwest at slope damage caused by vehicle traffic on landward slope.

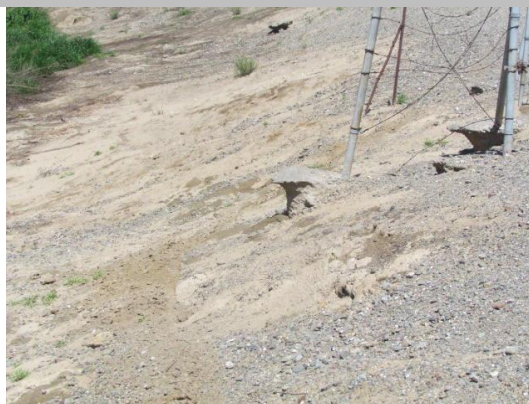
Photo 1 of 3 : SP_2017_RD0524_107_215_20170316_00250.jpg

Looking north at damage slope on landward slope.

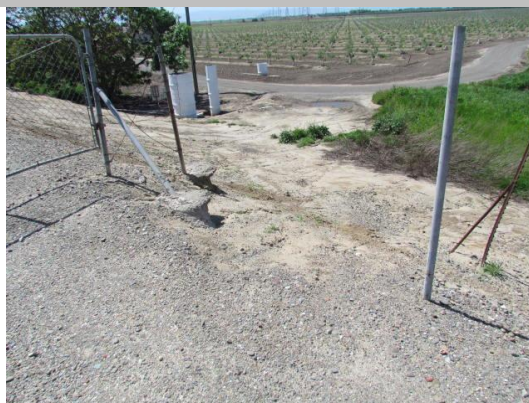
Photo 3 of 3 : SP_2017_RD0524_107_215_20170316_00252.jpg

Looking west at damage slope on landward slope.

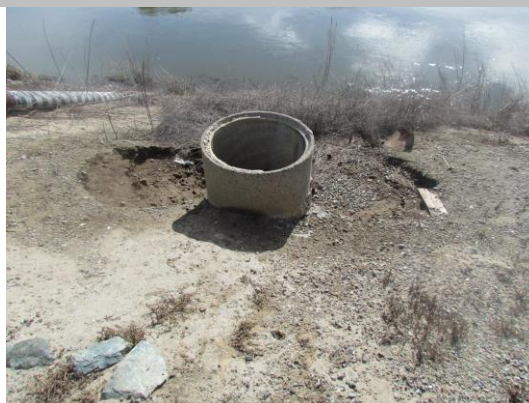
Photo 3 of 3 : SP_2017_RD0524_107_183_20170407_00399.jpg

Looking east at erosion on waterward slope.
